**Flood Control Project Maintenance
Levee Inspections**

Fall 2012 Levee Maintenance Deficiency Summary Report

San Joaquin River Basin

Reclamation District No. 0017 Mossdale

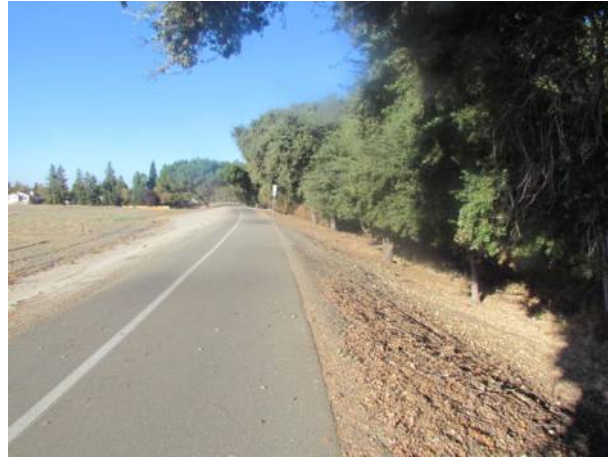
Levee Mile Report Line	4
Start Levee Mile	0.00
End Levee Mile	1.79
Location	Water Side
Category	Earthen Levee
Item	Vegetation

Looking north at typical view of waterside slope.

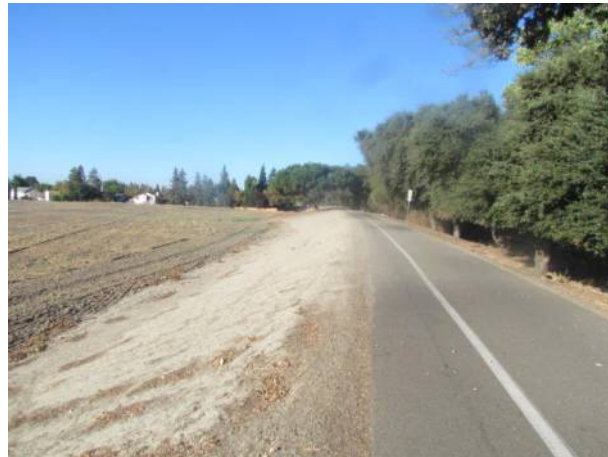
Levee Mile Report Line	5
Start Levee Mile	0.00
End Levee Mile	1.79
Location	Land Side
Category	Earthen Levee
Item	Vegetation

Looking north at typical view of landside slope.

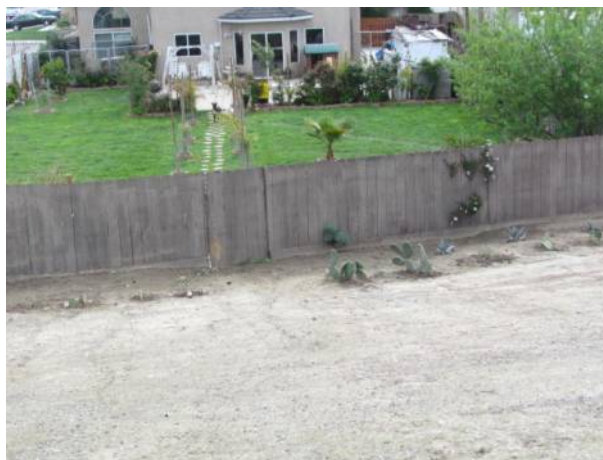
Levee Mile Report Line	3
Start Levee Mile	0.83
End Levee Mile	0.83
Location	Land Side
Category	Earthen Levee
Item	Encroachments

Looking west at new cactus plantings on landside toe.

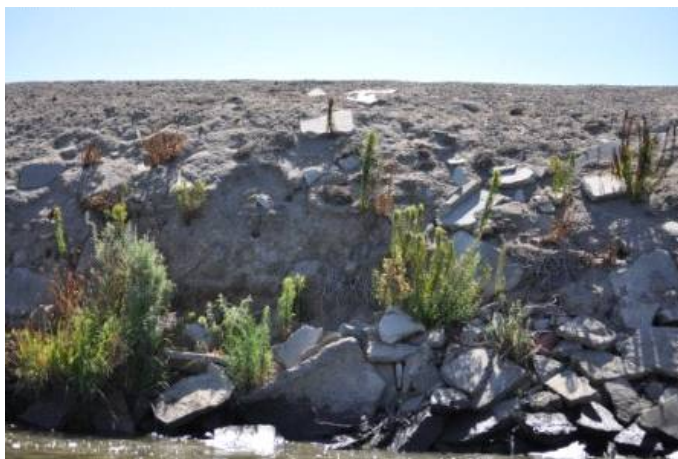
Levee Mile Report Line	4
Start Levee Mile	1.08
End Levee Mile	1.08
Location	Water Side
Category	Supplemental
Item	DWR Erosion Survey

Front view of erosion site. Note the concrete blocks and vegetation.

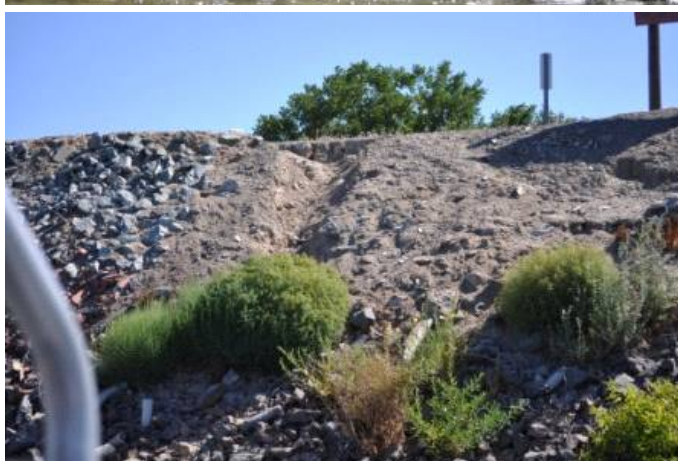
Levee Mile Report Line	6
Start Levee Mile	3.46
End Levee Mile	3.46
Location	Water Side
Category	Supplemental
Item	DWR Erosion Survey

Front view of the site. Note the riprap protection next to the site.

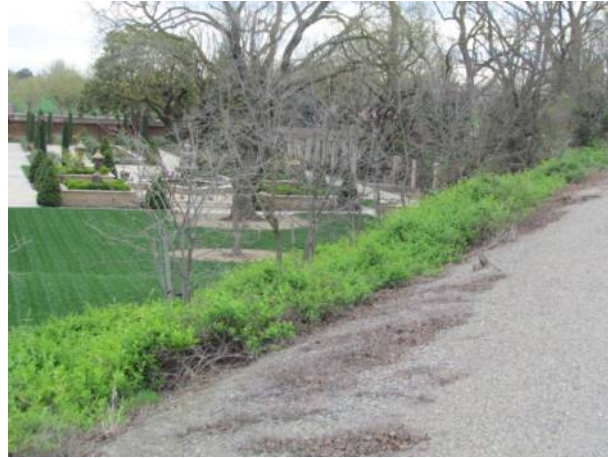
Levee Mile Report Line	7
Start Levee Mile	4.24
End Levee Mile	4.27
Location	Land Side
Category	Earthen Levee
Item	Vegetation

Looking southeast at dense ground cover on landside slope.

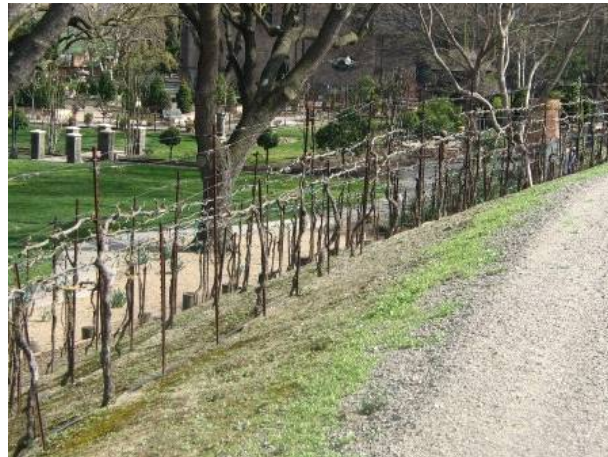
Levee Mile Report Line	8
Start Levee Mile	4.28
End Levee Mile	4.32
Location	Land Side
Category	Earthen Levee
Item	Encroachments

Grape vines on landside slope from LM 4.28 to 4.32

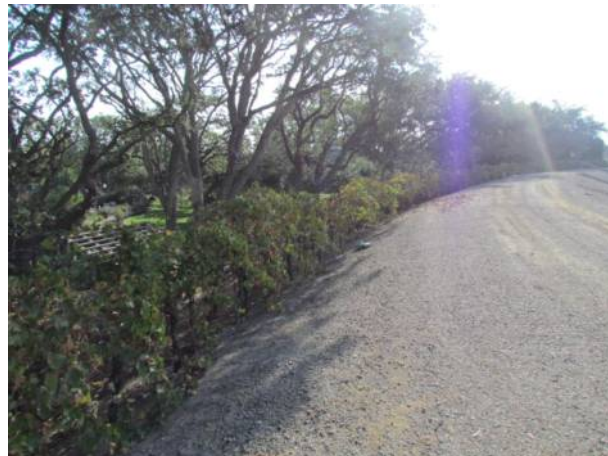
Levee Mile Report Line	8
Start Levee Mile	4.28
End Levee Mile	4.32
Location	Land Side
Category	Earthen Levee
Item	Encroachments

Looking southeast at grape vines on landside slope

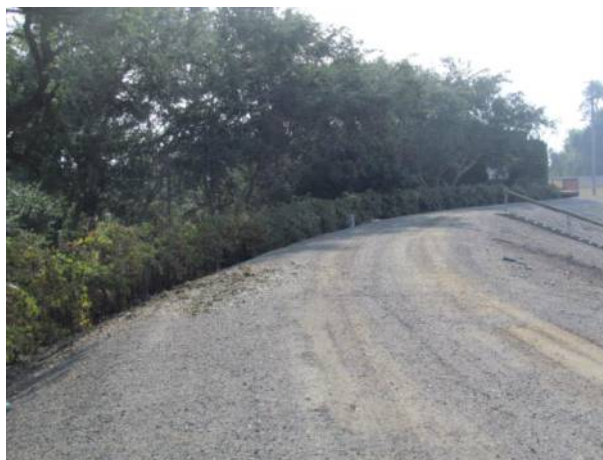
Levee Mile Report Line	8
Start Levee Mile	4.28
End Levee Mile	4.32
Location	Land Side
Category	Earthen Levee
Item	Encroachments

Looking south at landscaping with grape vines on landside slope

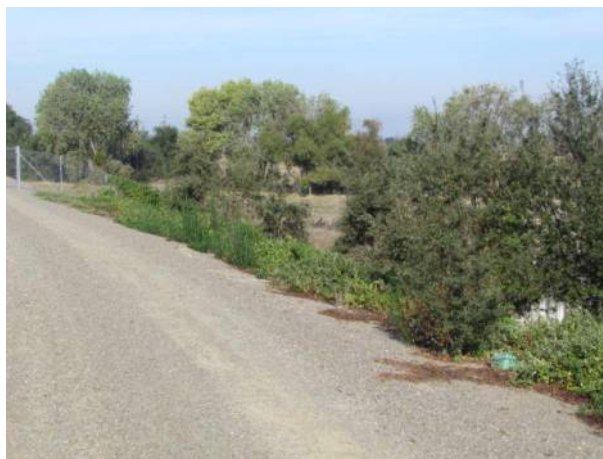
Levee Mile Report Line	8
Start Levee Mile	4.28
End Levee Mile	4.32
Location	Land Side
Category	Earthen Levee
Item	Encroachments

Looking northeast at dense landscaping on landside slope.

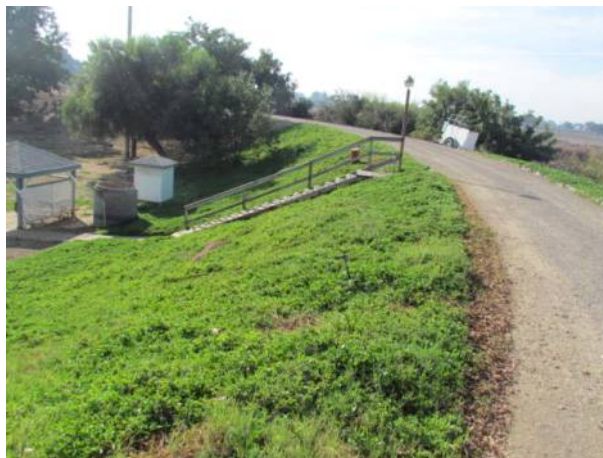
Levee Mile Report Line	9
Start Levee Mile	4.42
End Levee Mile	4.44
Location	Land Side
Category	Earthen Levee
Item	Vegetation

Looking southeast at ground cover on landside slope.

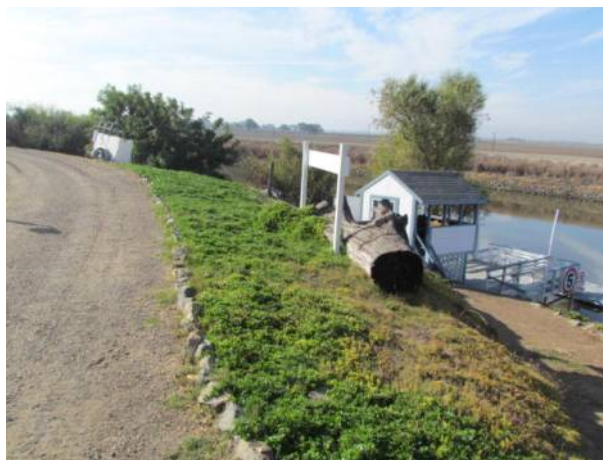
Levee Mile Report Line	9
Start Levee Mile	4.42
End Levee Mile	4.44
Location	Land Side
Category	Earthen Levee
Item	Vegetation

Looking southwest at landscaping and boat dock on waterside slope and channel.

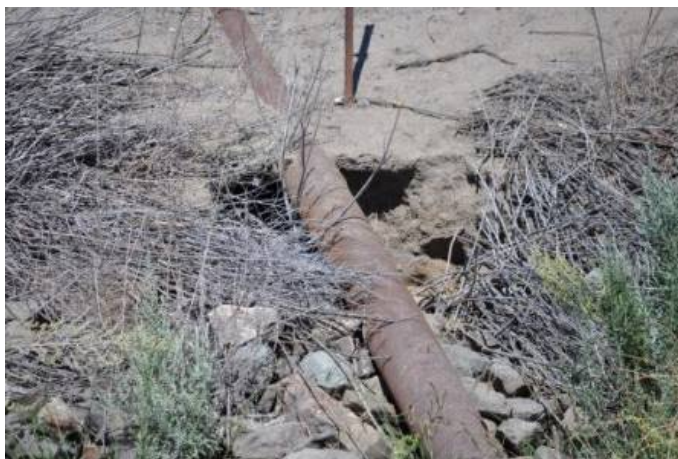
Levee Mile Report Line	12
Start Levee Mile	5.43
End Levee Mile	5.43
Location	Water Side
Category	Supplemental
Item	DWR Erosion Survey

Close view of the erosion and the pipe

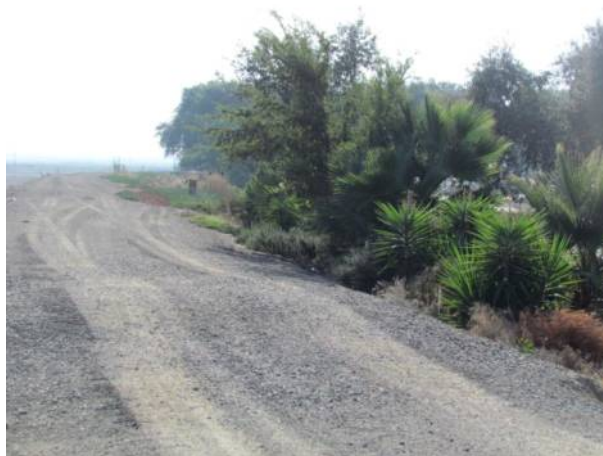
Levee Mile Report Line	15
Start Levee Mile	5.62
End Levee Mile	5.85
Location	Land Side
Category	Earthen Levee
Item	Vegetation

Looking south at overgrown landscaping on waterside slope.

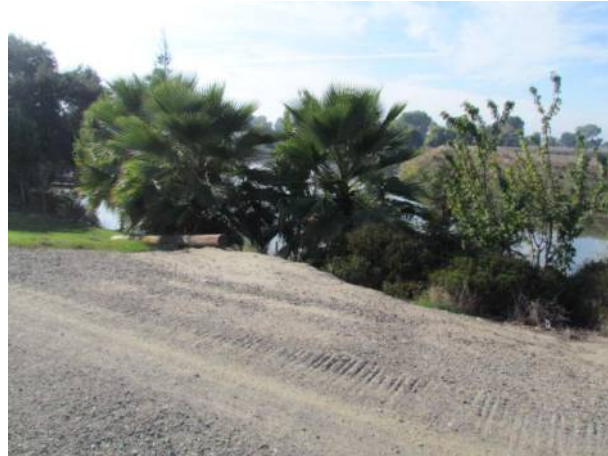
Levee Mile Report Line	15
Start Levee Mile	5.62
End Levee Mile	5.85
Location	Land Side
Category	Earthen Levee
Item	Vegetation

Looking west at landscaping on waterside slope.

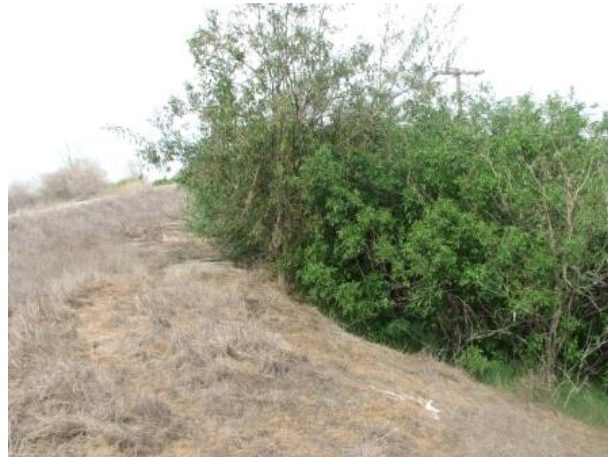
Levee Mile Report Line	19
Start Levee Mile	7.67
End Levee Mile	7.69
Location	Land Side
Category	Earthen Levee
Item	Vegetation

Elderberry blocking view of landside slope and toe from LM 7.67 to 7.69

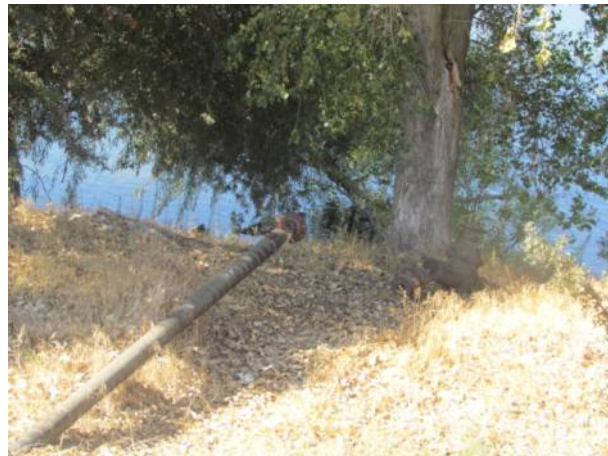
Levee Mile Report Line	21
Start Levee Mile	12.47
End Levee Mile	12.47
Location	Water Side
Category	Earthen Levee
Item	Encroachments

Looking west at disconnected pipe on waterside slope.

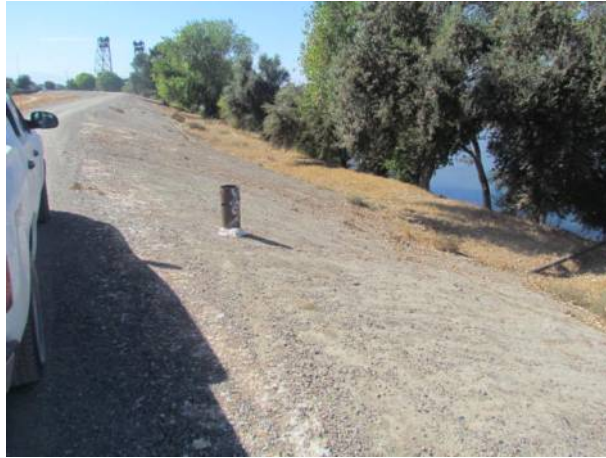
Levee Mile Report Line	21
Start Levee Mile	12.47
End Levee Mile	12.47
Location	Water Side
Category	Earthen Levee
Item	Encroachments
Looking southwest at siphon on waterside shoulder and slope.	
richard_f_20121008_052.JPG
